Board of Inquiry into McCrae Landslide

Prepared for: Thomson Geer 30 July 2025 Client Reference No. SMEC 002 Rev0

Document Type	Multidisciplinary Expert Supplementary Report
Project Title	Board of Inquiry into McCrae Landslide
Project Number	30043649
File Location	X:\Projects\300436\30043649 McCrae\900 xx Other\Supplementary Report
Revision Number	1

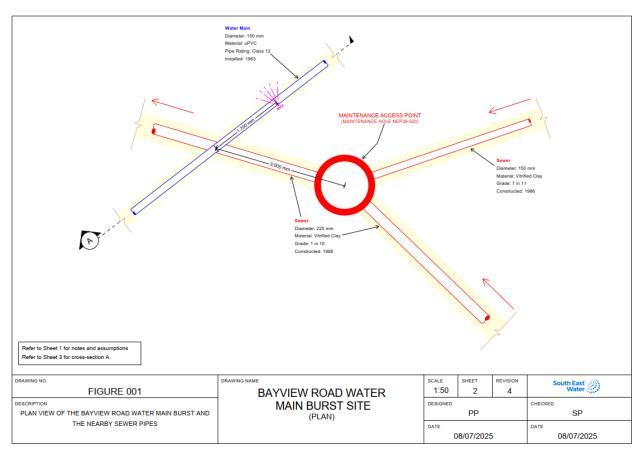
Figure 23, Figure 24 and Figure 25 have been produced by SEW to describe the vicinity of the Bayview Road leak, with particular emphasis on pipe embedment. The figures note that the sewer bedding material, according to the standard drawing of a previous sewerage authority, comprises a coarse aggregate. SEW has confirmed the embedment material in recent excavation works. Above this material, the embedment material comprises sand. The mains pipe crossing over the sewerage also comprises sand embedment material.

Figure 24: Plan view of Bayview Road water main burst & nearby sewer pipes

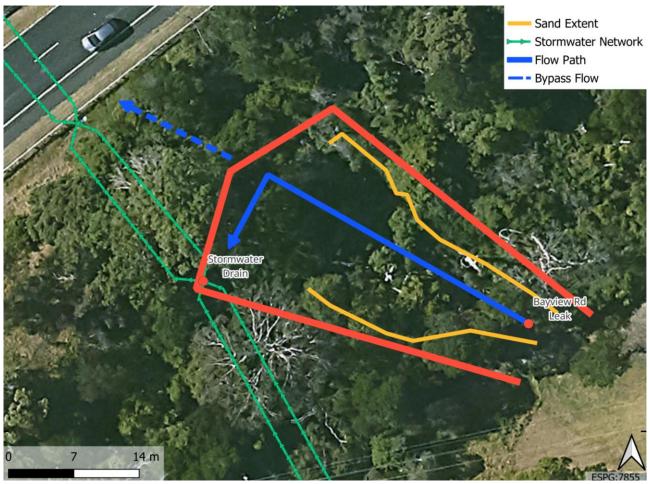
The figure notes a 'bypass flow' continuing north of the stormwater grate and down the cut slope of the M11. It should be noted that the model developed does not represent the channel running parallel to the direction of traffic along the M11, outfalling into the stormwater grate well. Therefore, the lack of visual confirmation that the Bypass flow happened is allowed for by the slight discrepancies of the model. The model outputs note that the Bypass flow accounts for only a small percentage (3% for the 10 L/s model, and 5% of the 20 L/s model) of the overall flow and it is very shallow.

Figure 34: Schematic model of the Bayview Road leak showing surface extents and possible flow paths

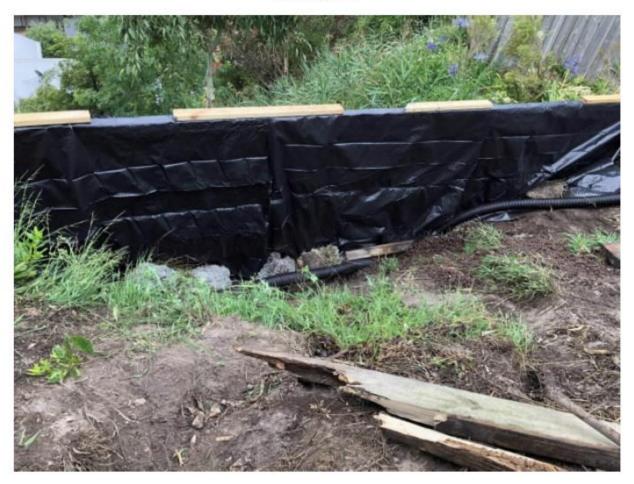
GB-12 Retaining Wall

Figure 1: GB-12, taken from Annexure of Witness Statement of G Borghesi, showing construction of original retaining wall,

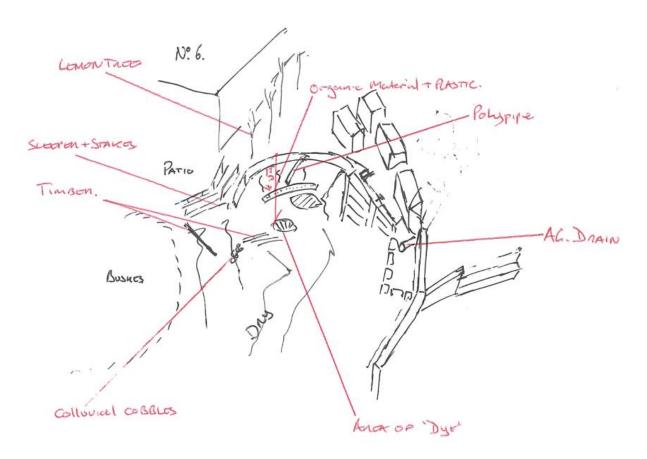
However, it is noted that available, safe locations to view possible seepage are approximately 6 m from the source of seepage, and as vegetation starts to recolonise the base of the landslip, it is reasonable to assume that seepage, minor comparison to the seepage following the landslides, does occur within the landslide.

Figure 2: Sketch showing features noted by SMEC of the McCrae Landslip, from vantage points within 10-12 View Point Road property extents.

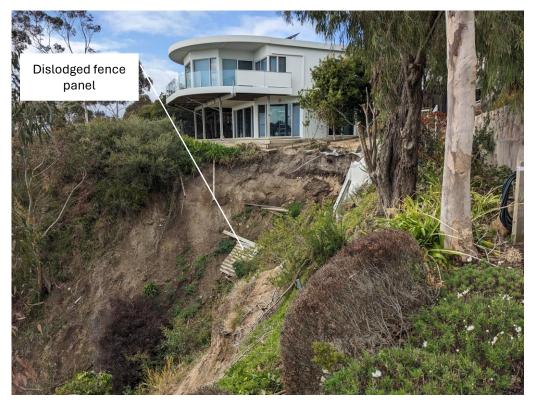
Figure 6: 17/6/25 Photo 03 Looking east showing the upper slope of the escarpment, and assumed extent of slip, showing debris downslope of the backscarp

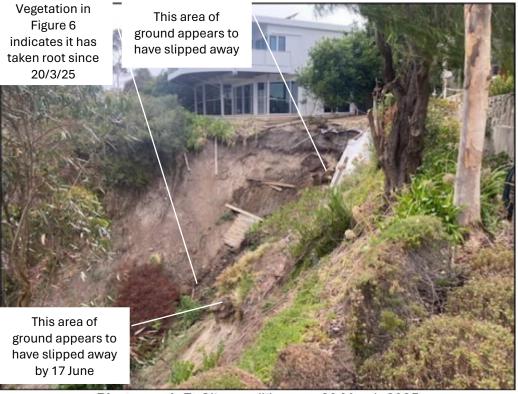
Figure 7 is included to enable the reader to compare a photo taken by CivilTest on 20 March 2025, and included in the CivilTest letter to Mr. Borghesi on 4 April 2025 (Appendix B Ref 4), to Figure 6. Some deterioration appears to have occurred in the time between the two photographs.

Photograph 7: Site conditions on 20 March 2025

Figure 7: 20/3/25 taken from CivilTest Letter dated 4 April 2025 Reference 1222044-15.

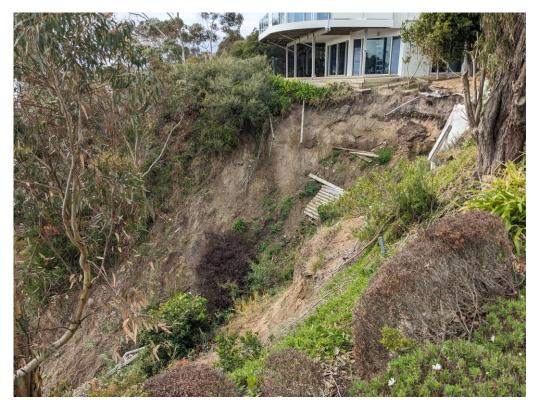
Figure 8: 17/6/25 Photo 04 Looking east showing the detail of the backscarp. Note the vertical nature of the backscarp, approximately 4.5m high

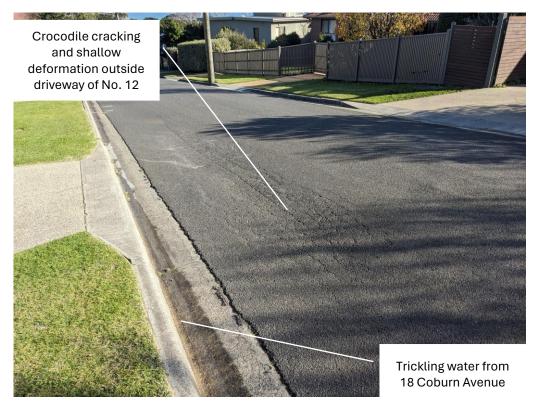
Figure 14: 20/6/25 12 Coburn Avenue, looking west showing condition of pavement

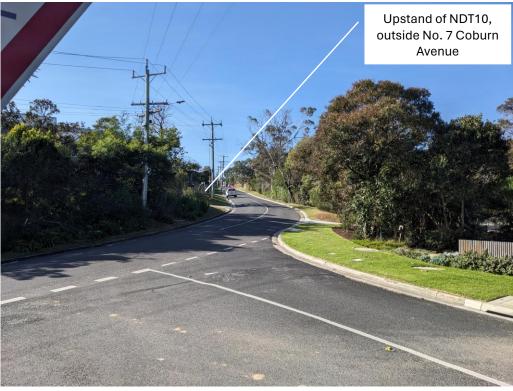
Figure 15: 20/6/25 Coburn Avenue looking east up hill towards NDT10, and location of locally saturated verge.

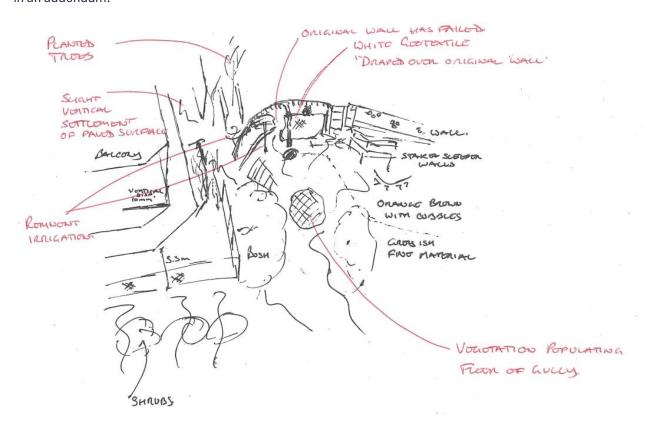
The exposed geology seemed to comprise a granular matrix with cobbles, overlying a greyish sandy material. The Council Building Surveyor pointed out suspected areas of 'piping' within the backscarp to SMEC personnel. The cause and exact nature of these areas were not confirmed by SMEC Engineers on site. Assessment of the dispersive nature of local geology is part of the scope of the SMEC intrusive investigation works, to be included in an addendum.

$Figure\ 16: Sketch\ showing\ features\ noted\ by\ SMEC\ of\ the\ McCrae\ Landslip,\ from\ vantage\ points\ within\ 6\ View\ Point\ Road\ property\ extents\ .$

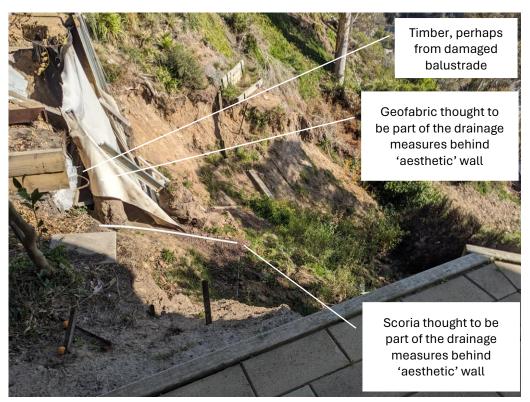
Figure 19: 20/6/25 Looking west showing failed slope material below retaining wall, note the vegetation at the floor of the failed material

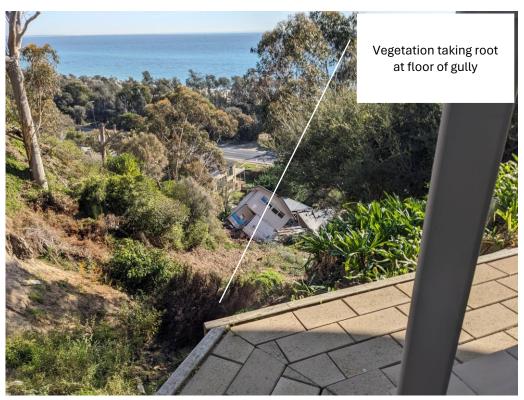
Figure 20: 20/6/25 looking north west showing debris flow towards Penny Lane

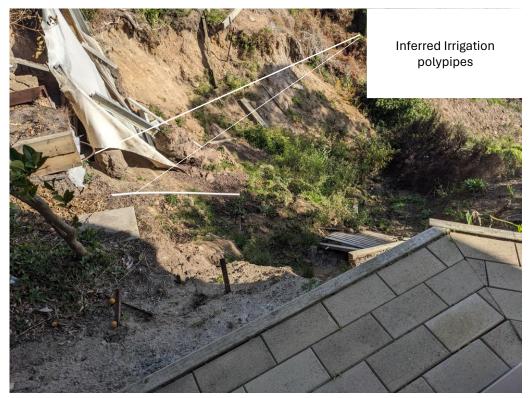
Figure 23: 20/6/25 Looking north west down the failure, showing depth of slope movement.

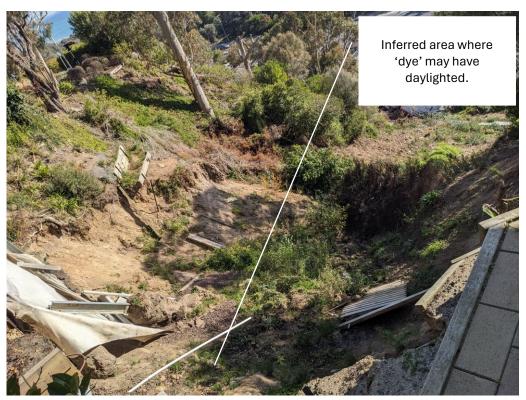
Figure 24: 20/6/25 6 View Point Road, looking north west showing path of landslip

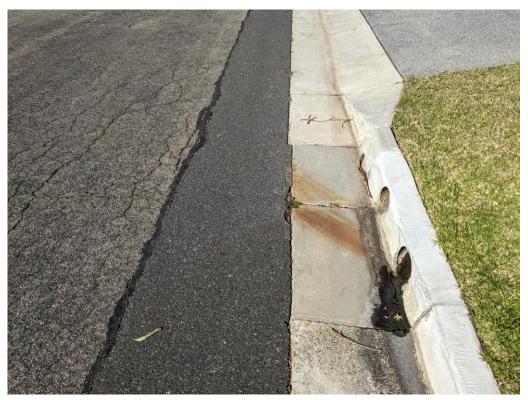
Figure 31: 20/6/25 5 Prospect Hill Road, looking south showing detail of staining flowing from the joint between asphalt and kerb

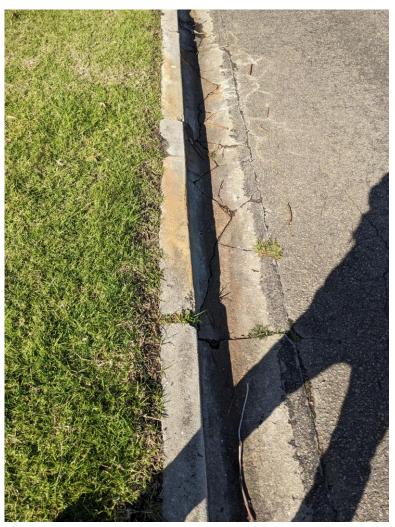
Figure 32: 20/6/25 Looking north form 6 Prospect Hill Road, showing cracking, and staining of kerb suggesting runoff has previously flowed over of kerb.

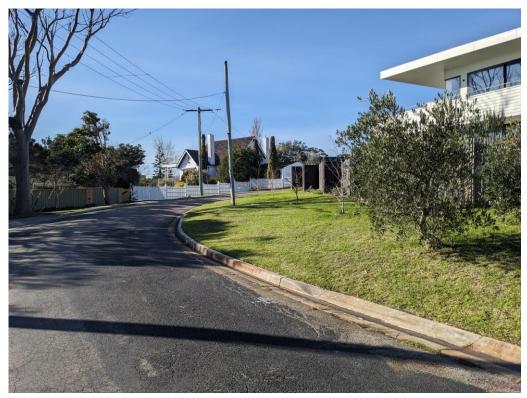
Mr. Hutchings said that he noted runoff down the hill of the verge early in the year, where Prospect Hill Road backs on to No. 27 Coburn Avenue.

Figure 33: 20/6/25 7 Prospect Hill Road, looking east showing verge

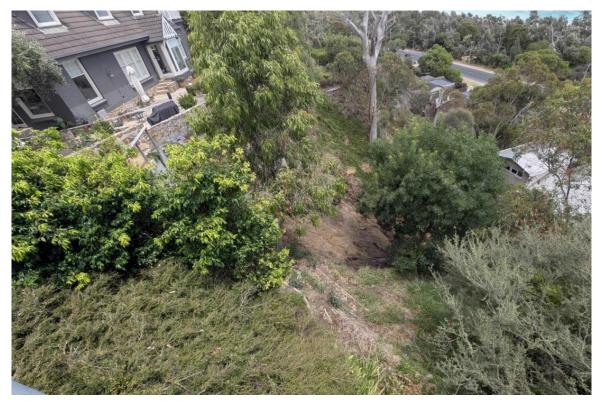
Figure 2: Looking at 5 January 2025 failure, taken on 7 January 2025 by Kevin Hutchings

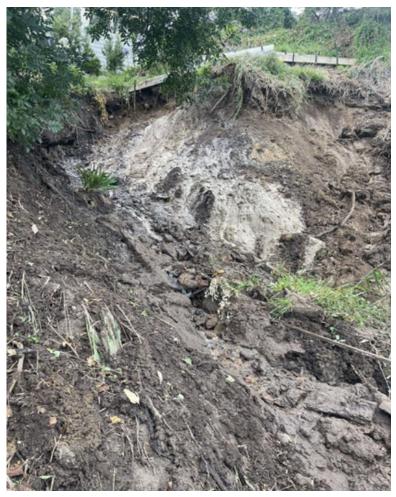
Figure 3: Photo taken by SEW personnel 6 January 2025 showing landslide from midslope of 10-12 View Point Road

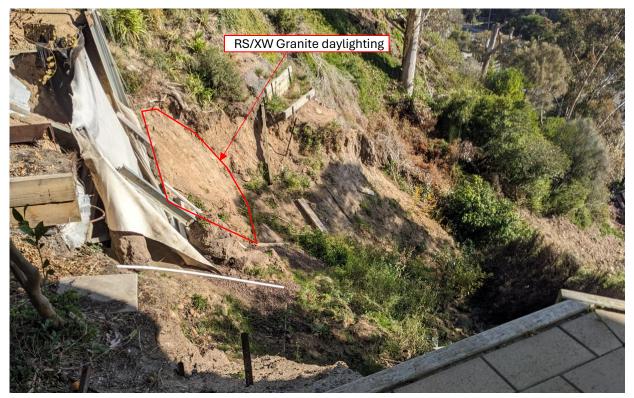
Figure 8: Site photograph looking at backscarp from 6 View Point Road

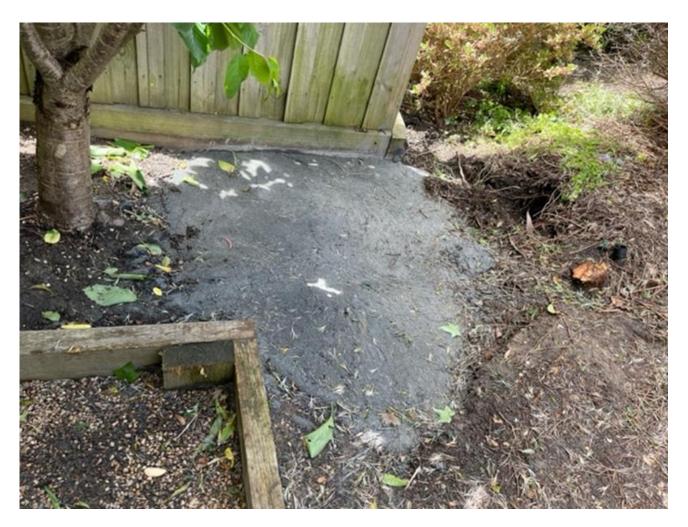
$Figure\ 25: Photograph\ from\ email\ of\ 22\ November\ 2022, showing\ detail\ of\ sinkhole\ repair\ within\ private\ land.$

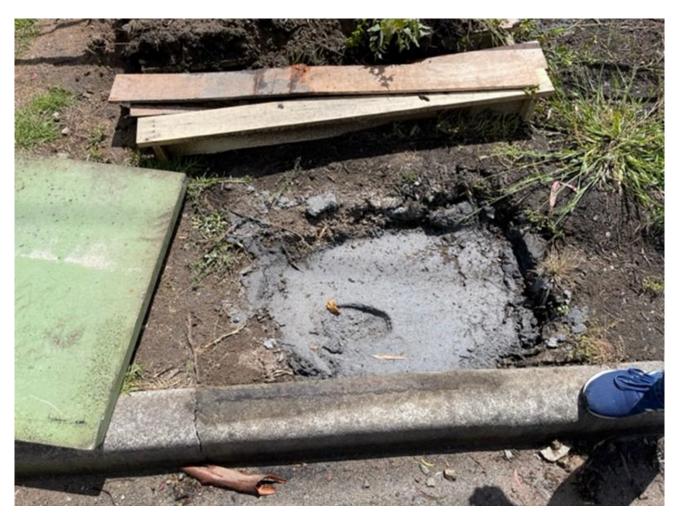
Figure 26: Photograph from email of 22 November 2022, showing detail of sinkhole repair adjacent to a kerb.

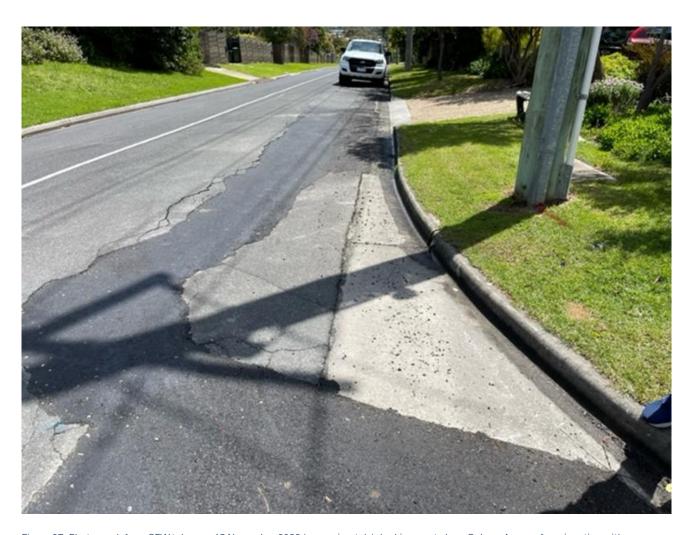
Figure 27: Photograph from SEW taken on 15 November 2022 (approximately), looking west along Coburn Avenue from junction with Prospect Hill Road showing completed mains repair works.
