Board of Inquiry into McCrae Landslide

Prepared for: Thomson Geer 30 July 2025 Client Reference No. SMEC 002 Rev0

Document Type	Multidisciplinary Expert Supplementary Report
Project Title	Board of Inquiry into McCrae Landslide
Project Number	30043649
File Location	X:\Projects\300436\30043649 McCrae\900 xx Other\Supplementary Report
Revision Number	1

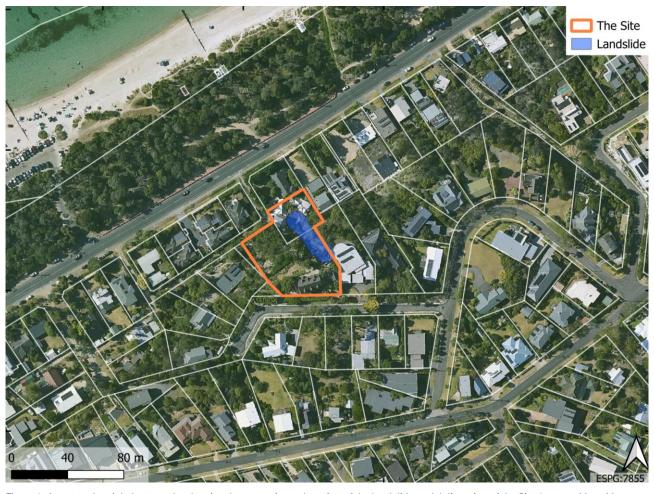
Figure 1: Annotated aerial photography showing the approximate location of the landslide and delineation of the Site (source: MetroMap; 2025-02-01. Annotation of site location added by SMEC)

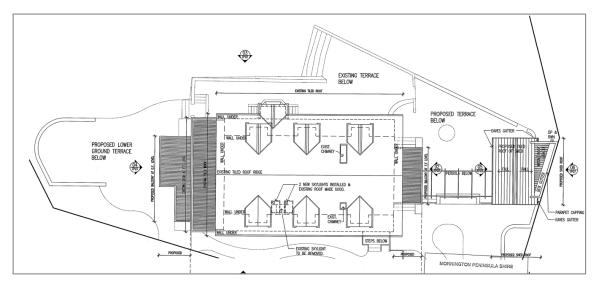
2015 to 2016 – applications were submitted for 10-12 View Point Road comprising alterations to the existing dwelling, extensions, a new outbuilding, retaining walls, hard paving, fences and gates. The submitted plan of the proposed alterations is presented in Figure 12. This plan indicates that new terraces were proposed either side of the house, and a new structure was proposed on the northeastern side of the house. The plans indicate an extension to the terrace on the north-eastern side of the house, requiring the construction of new retaining walls and placement of fill at the crest of the escarpment in the area that the 2025 landslides subsequently occurred.

Figure 12: Plan of proposed development at 10-12 View Point Road (source: JDA Architects – Appendix B, Ref 16)

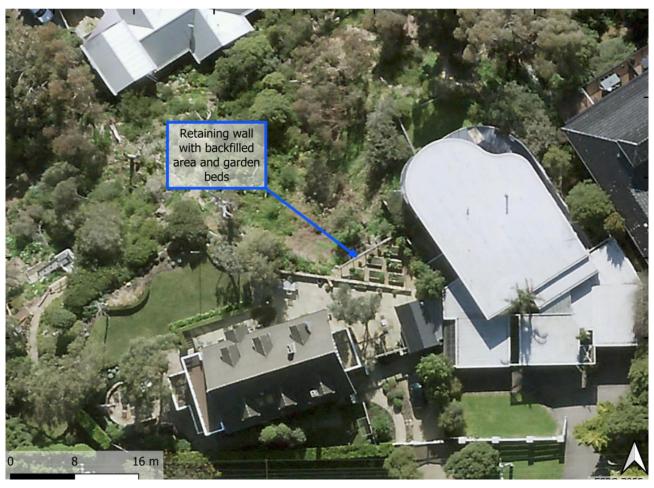
2020 to 2021 – applications were submitted for the installation of a deck and engineered handrail for the edge of a garden. The planning application appears to have been withdrawn at the request of the property owner (Appendix B, Ref. 17). Aerial imagery from Metromap (refer Figure 14) and available photographs indicate that a post and timber panel retaining wall with backfill was completed prior to 30 December 2021 and raised garden beds installed on the backfill by 21 July 2022.

Figure 14: Aerial imagery of 10-12 View Point Road from 21 July 2022 (source: MetroMap accessed on 5 July 2025. Annotation added by SMEC)

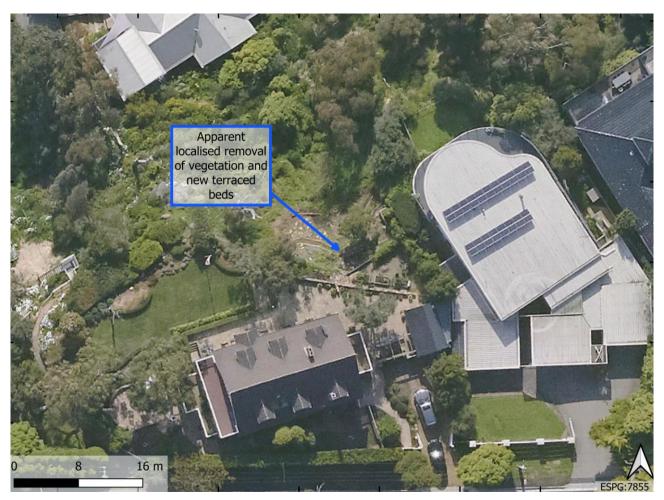
Late 2022 – A steel post and timber plank retaining wall, understood from discussions with Mr. Borghesi during SMEC's site visit of 17 June 2025 (Appendix C) estimated to be up to 900 mm high was constructed, to create a flat area for raised vegetable garden beds behind and across the slope (refer Figure 15). Some fill would have been required to infill behind the wall (Appendix B, Ref 25).

Figure 15: Aerial imagery of 10-12 View Point Road from August 2023 (source: MetroMap accessed on 5 July 2025. Annotation added by SMEC)

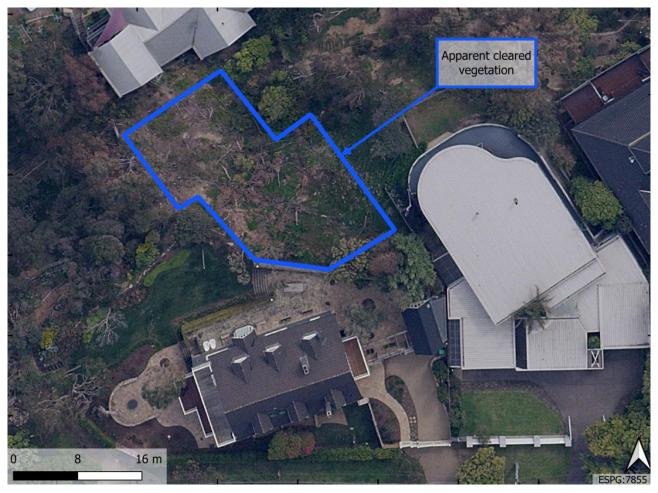
These observations indicate that there have been various instances of vegetation clearing at the Site between 2017 and 2023, including within the area that the 2025 landslide occurred. However, we are not aware of any evidence of significant changes between 2023 and the landslides in 2025. An example of an aerial image indicating removal of vegetation in 2018 is presented in Figure 16.

Figure 16: Aerial imagery of 10-12 View Point Road from September 2018 (source: MetroMap accessed on 5 July 2025. Annotation of vegetation clearing added by SMEC)

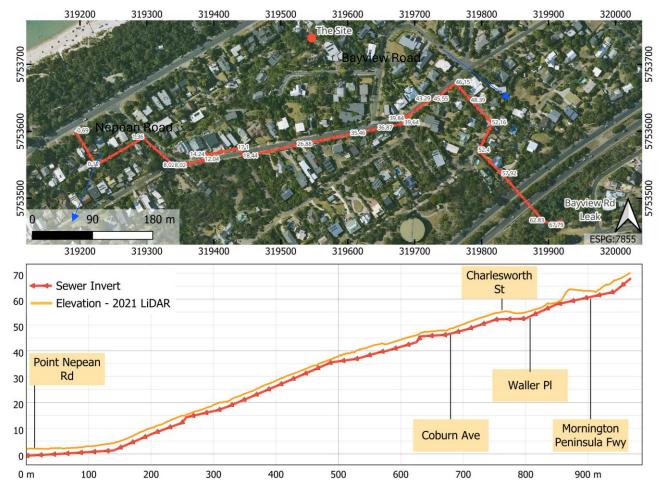
Figure 19 highlights the section of the sewer network between Bayview Road and Point Nepean Road. Chainages 217.75m to 298.25m are located along Charlesworth Street. The depth to invert along Charlesworth Street varies from 2.69m to 1.56m. It is noted that the invert depths along Charlesworth Street are not the shallowest inverts along the alignment.

Figure 19: Graphical long section showing the ground level and invert levels of the sewer network between Bayview Road and Point Nepean Road.

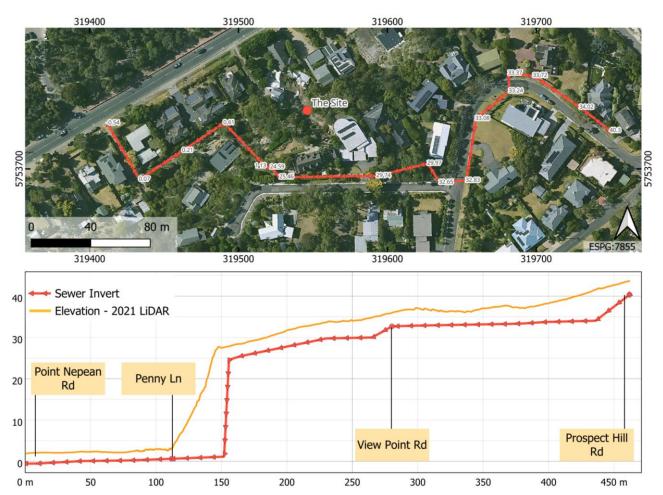
Figure 20 below illustrates the sewer gradient through Prospect Hill Road into View Point Road. 10 View Point Road is at chainage 298.4m. These figures show a fall in invert level along the chainages, irrespective of the ground level. Chainages 83.9m to 93.7m is outside of 10 Prospect Hill Place.

Figure 20: Graphical long section showing the ground level (CL) and invert levels (IL) of the sewer network between Prospect Hill Road and Point Nepean Road.

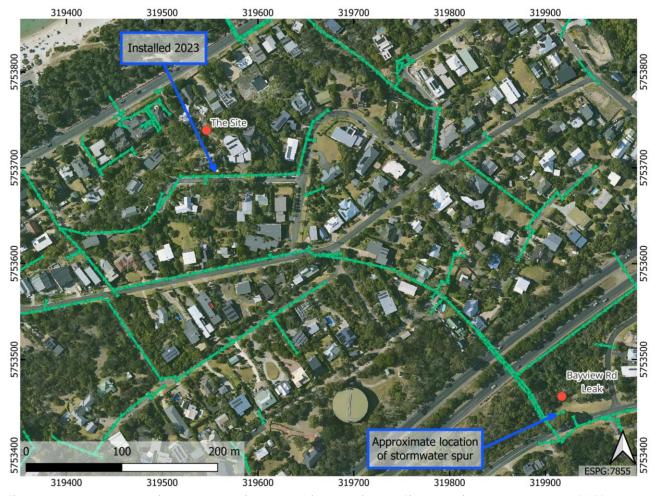
A plan of the stormwater network is presented in Figure 21. This plan has been annotated by SMEC to show the approximate location of known buried stormwater drainage that was installed along View Point Road in 2023. This figure is derived from Before You Dig Australia (BYDA) maps, which have been acknowledged to be incorrect by MPSC. No as-built drawings or site records of these construction works were available to SMEC at the time of writing this report. Based on conversations with MPSC, SMEC understands that the stormwater drainage flows from the front of No.4 to No.22 View Point Road. Drainage is located around the bend of Prospect Hill Road which SMEC understands connects to the newly installed drain along View Point Road.

Based on a memo from SEW, dated 15 May 2025, a separate 'spur' of the stormwater drainage system was identified and confirmed with MPSC on 15 May 2025. This spur is also shown in Figure 21, located near the Bayview Leak site. Given the likelihood that the construction of this spur is similar to other stormwater drainage lengths, it is reasonable to suggest that the embedment material of the spur comprises fine crushed rock or select fill. It is therefore reasonable to suggest that any perched water, or seepage from the Boulevard reserve may be in part, or in total be collected by the spur and the embedment material.

Figure 21: Map (not scaled) showing stormwater drainage network in the locality of the Site. Annotations have been added by SMEC of the stormwater drainage constructed in 2023 and known 'spur' confirmed by MPSC

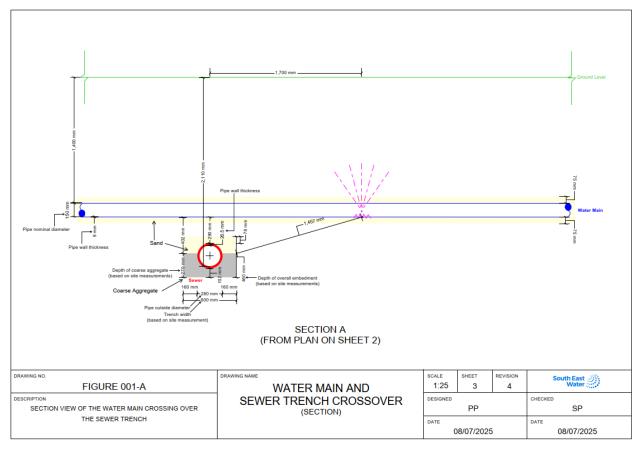
Figure 23, Figure 24 and Figure 25 have been produced by SEW to describe the vicinity of the Bayview Road leak, with particular emphasis on pipe embedment. The figures note that the sewer bedding material, according to the standard drawing of a previous sewerage authority, comprises a coarse aggregate. SEW has confirmed the embedment material in recent excavation works. Above this material, the embedment material comprises sand. The mains pipe crossing over the sewerage also comprises sand embedment material.

Figure 25: Section view of the Bayview Road water main crossing over sewer trench

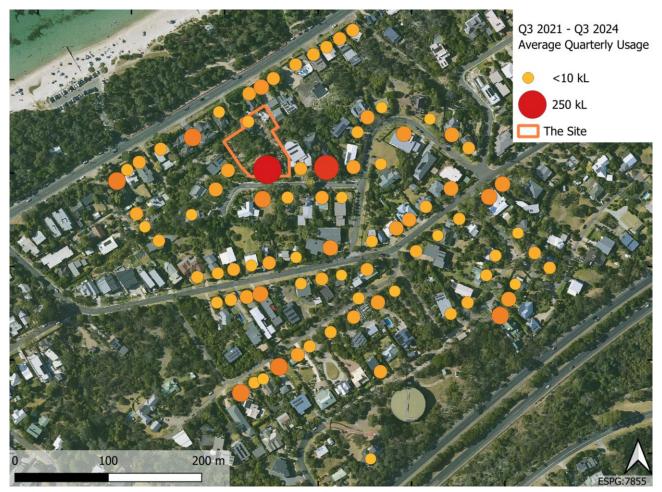
Figure 26: Private water usage of properties in the vicinity of the Site

Water usage of Nos 4 and -12 View Point Road is greater than the area average for permanent occupancy for all quarters since Q3 2021, up to, and including, Q4 2024. It was noted during the SMEC site visits, that there was a substantial irrigation system within the gardens of No. 10-12 View Point Road. SEW water understands that No. 4 View Point Road has an irrigation system installed.

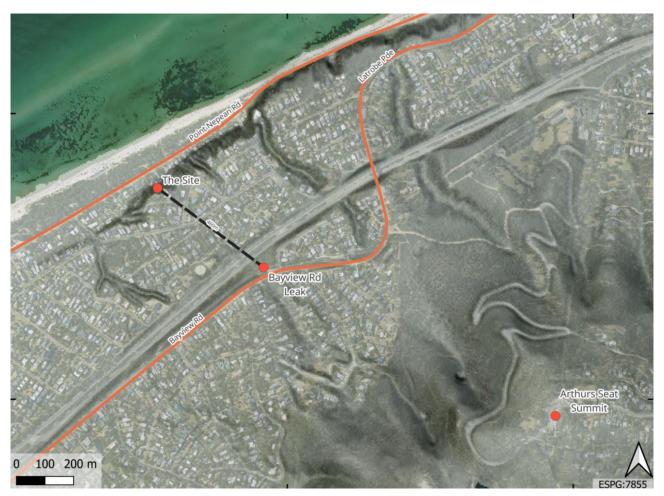
Numerous witness statements and SEW's own records detail a leak that occurred due to a fracture within a PVC water pipe near Bayview Road, approximately 450 m, south and upslope from the Site. SEW has advised that the fracture was located on 30 December 2024 and repaired on 1 January 2025. The date that the water leak began is thought to be in early August 2024 according to a report from the University of Auckland (Appendix B Ref. 40). Residents began to report potential leaks at Charlesworth Street and Waller Place between 26 November 2024 and 1 January 2025. The University of Auckland report estimated, based on SEW raw data, that the volume of water that may have been lost through the leak was 40.3 Ml.

$Figure\ 27: Plan\ showing\ the\ location\ of\ the\ water\ main\ leak\ at\ Bayview\ Road\ in\ relation\ to\ the\ Site$

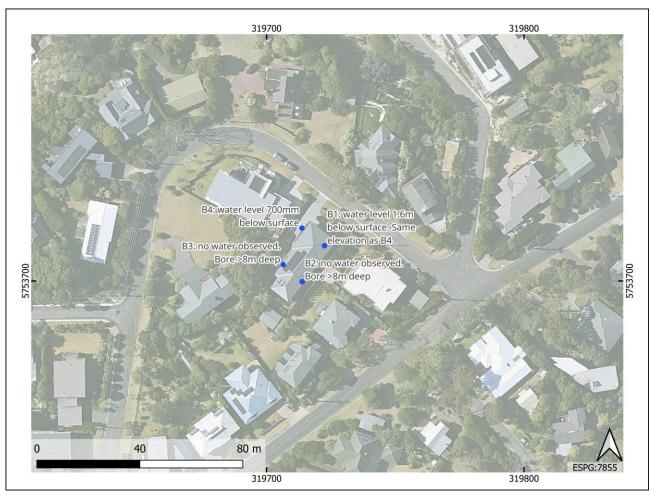
The test results referred to by the landowner were taken on 25 September 2018, within boreholes Bore 3 and Bore 4 as shown in Figure 28. A control sample from Tap water was also taken. Fluoride levels of the samples taken from BGH3 and BH4 were 0.7 mg/l, and 0.6 mg/l compared to 0.5 mg/l for the tap water.

Figure 28: Locations of boreholes drilled in 2018 prior to the construction of No. 5 Prospect Hill Road, noting water level observations.

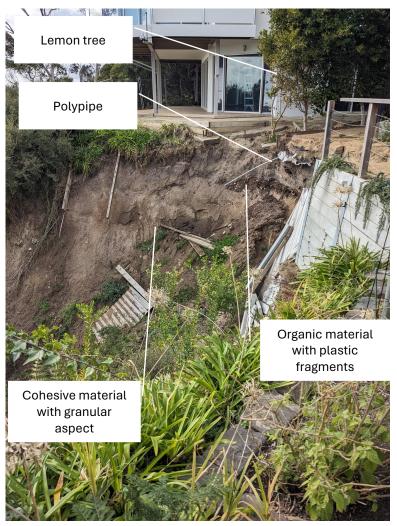
Figure 4: 17/6/25 Photo 01 Looking east showing the detail of the backscarp. Note the vertical nature of the backscarp, approximately 4.5m high.

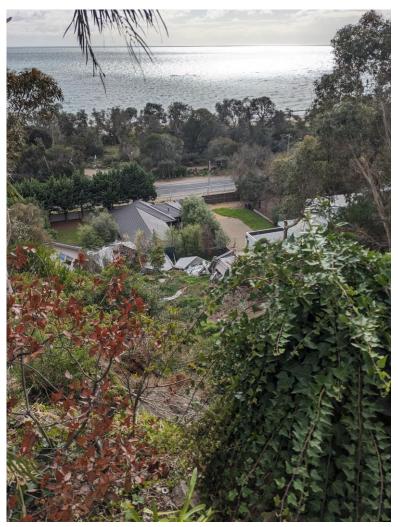
Figure 5: 17/6/25 Photo 02 Looking north showing the extent of landslip

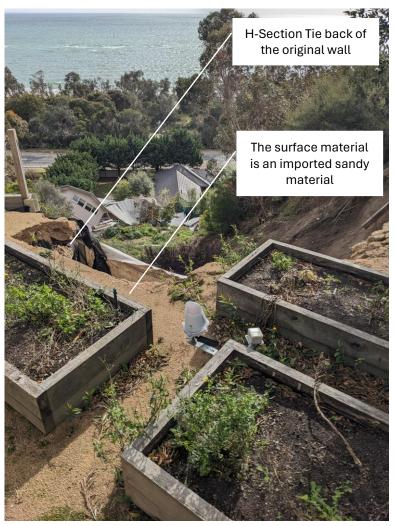
Figure 9: 17/6/25 Photo 06 Looking north from behind the raised vegetable patch, towards the toe debris of the landslip. The tie back of the original retaining wall is visible, as is the white geofabric of the drainage measures of the 'aesthetic' wall

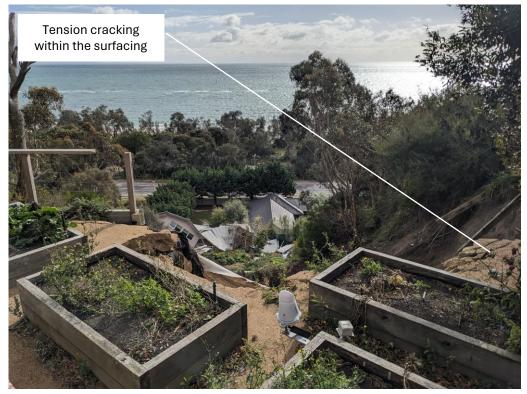
Figure 10: 17/6/25 Photo 07 Looking north, down the direction of the landslip

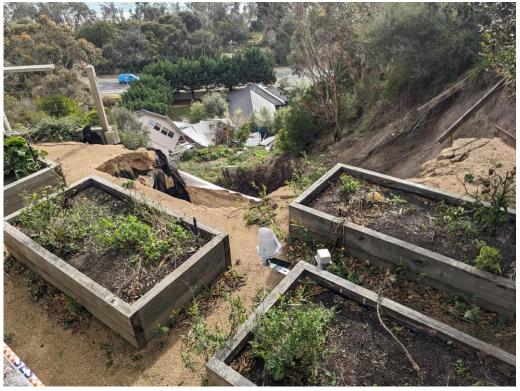
Figure 11: 17/6/25 Photo 08 Looking north over the vegetable garden, showing the crest of the backscarp

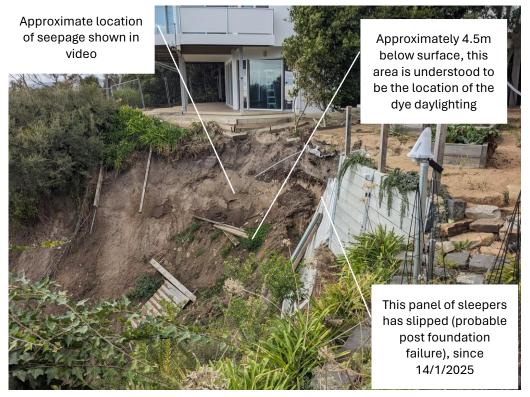
Figure 12: 17/6/25 Photo 09 Looking east showing the location of the seepage videoed by the landowners on 14 January 2025, and location of the dye that was seen daylighting through the backscarp after dye was poured into NDT01/02.

Figure 12 should be compared with Figure 13, which shows three panels of sleepers of the retaining wall still standing.

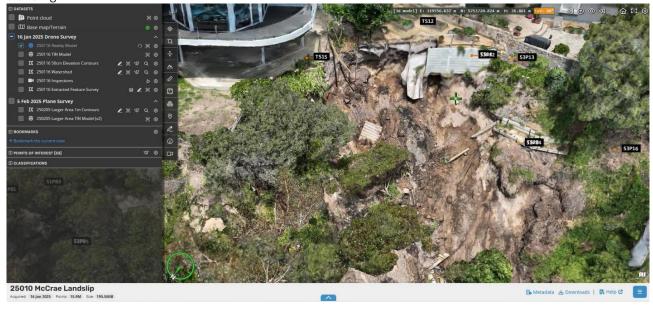
Figure 13: Detail of the landslip drone footage taken on 15/1/25.

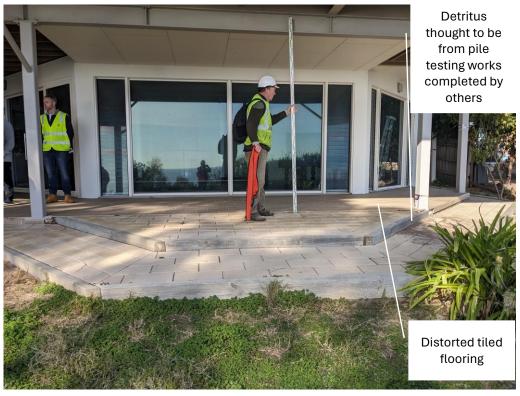
Figure 17: 20/6/25 6 View Point Road, looking south note the disturbed paving, but the house does not show signs of movement.

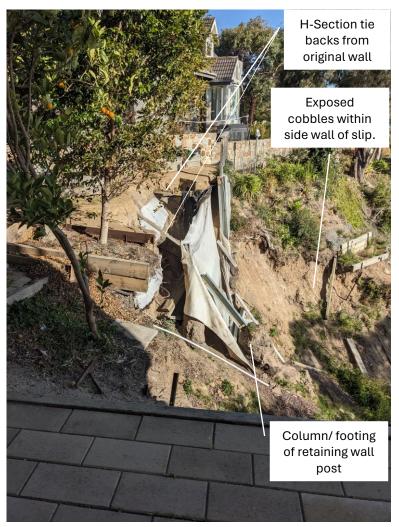
Figure 18: 20/6/25 6 View Point Road looking west along line of retaining walls, showing tie backs, and several irrigation pipes

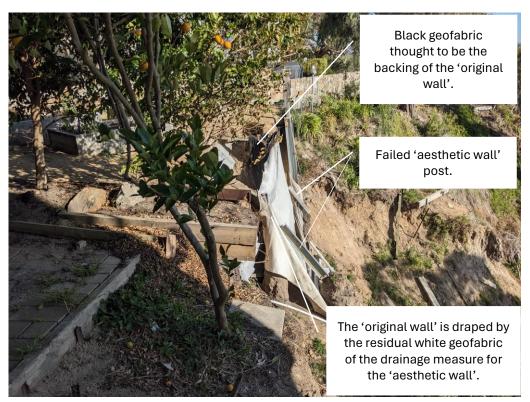
Figure 21: 20/6/25 looking west, showing lemo tree in the foreground, with colluvial material exposed in background.

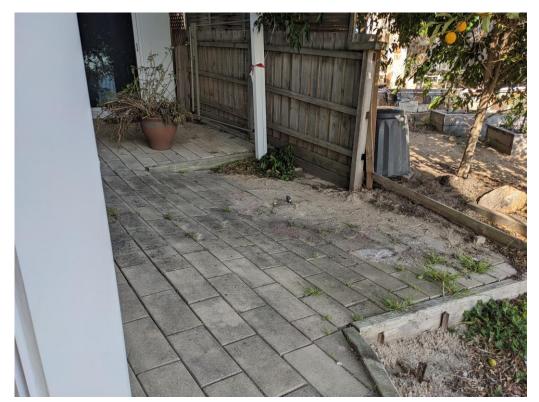
Figure 25: 20/6/25 6 View Point Road, looking south towards fencing with No. 10, showing disturbed ground.

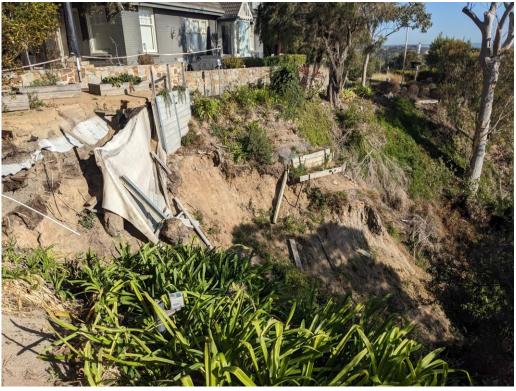
$Figure\ 26:\ 20/6/25\ Looking\ west\ from\ 6\ View\ Point\ Road.\ Note\ the\ change\ in\ geology\ below\ the\ wooden\ sleepers.$

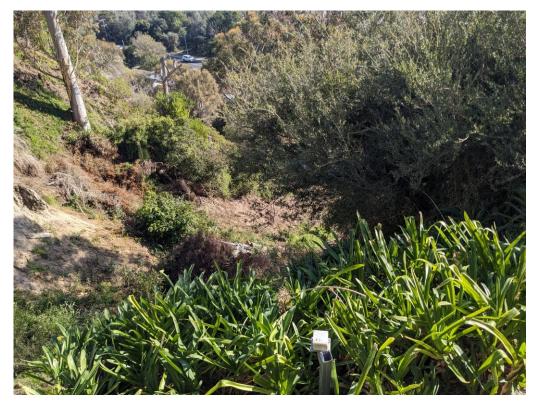
Figure 27: 20/6/25 6 View Point Road, showing evidence of vegetation growth.

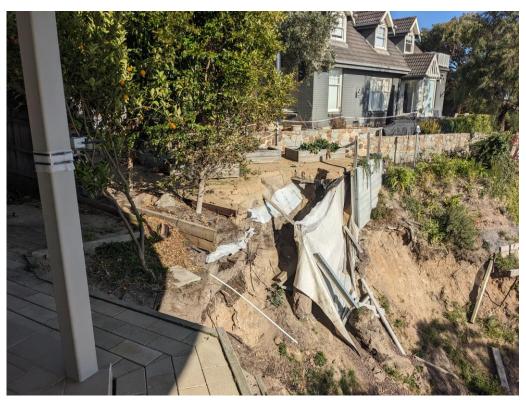
Figure 28: 20/6/25 6 View Point Road looking west. Note the leaning back of the retaining wall posts

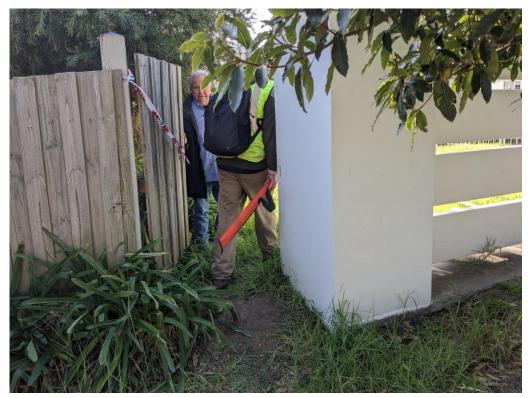
Figure 29: 20/6/25 6 View Point Road looking north showing front gate which has had to be shaved due to toppling concrete pillar.

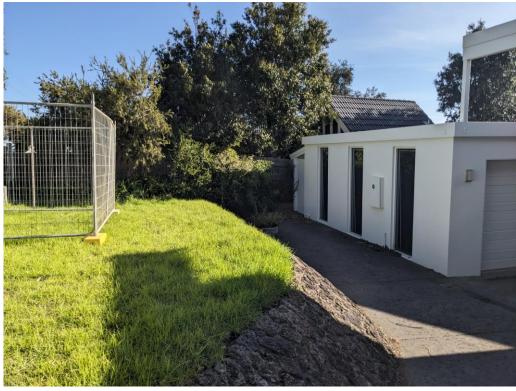
Figure~30:~20/6/25~6~View~Point~Road,~Front~Garden~looking~west~showing~platform~1m~high~where~NDT~01~was~drilled.

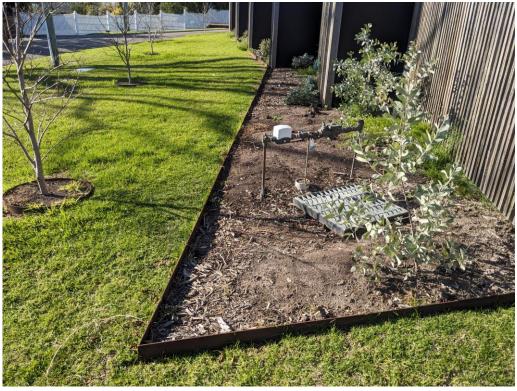
Figure 34: 20/6/25 7 Prospect Hill Road looking east showing gully pot where AG pipes from the property meet, flowing to Stormwater Pit outside No. 11.

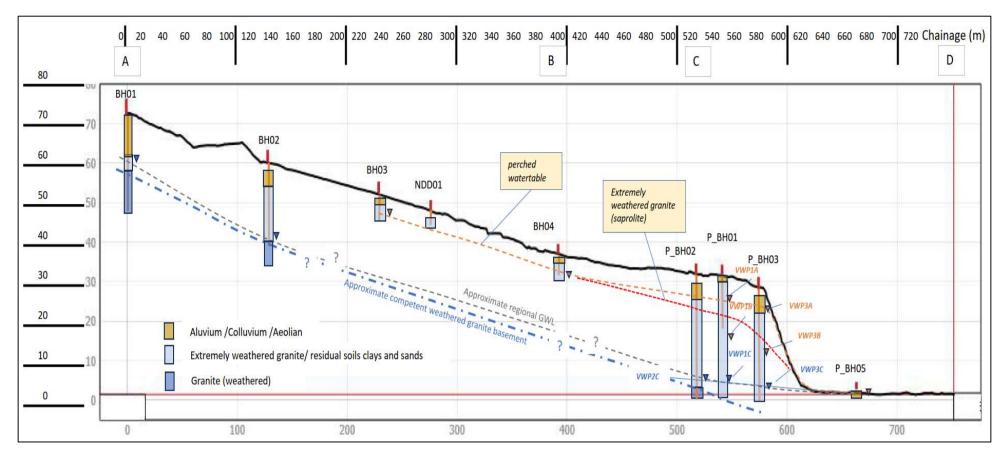
Figure 4: Interpretative hydrogeological cross section

Figure 4 below is a summary of aquifer zones intercepted by the drilling in the area and the groundwater levels.

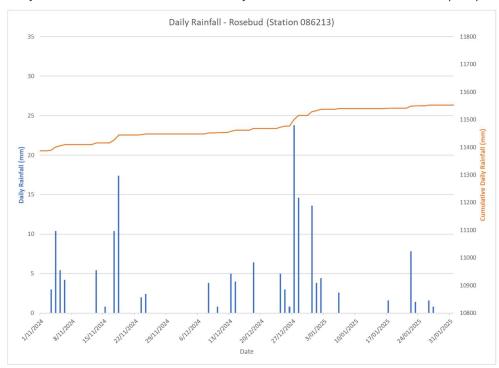
Figure 7: Daily Rainfall for Rosebud monitoring station 086213 for the period 1/11/24 to 31/1/25

The rainfall event preceding the 5 January 2025 landslip included a total of 60.2 mm of rain over a 7-day period from 27 November 2024 to 3 December 2024. The maximum rainfall occurred on 27 November 2024 (23.8mm). Another rain event of 21.8mm over 3 days (1st to 3rd January 2025) added moisture to already wet conditions.

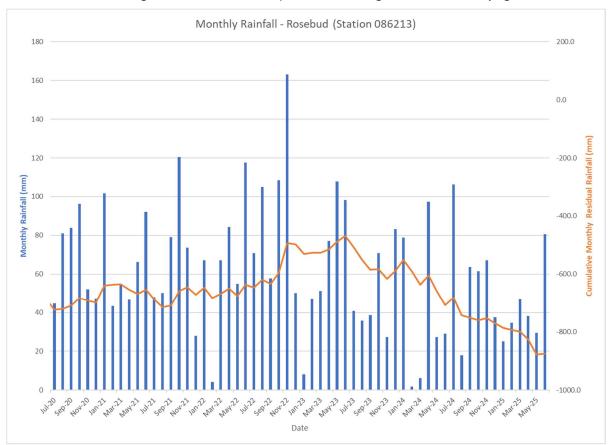
Figure 8: Cumulative Residual Monthly Rainfall for Rosebud rainfall station

The November 2024 monthly rainfall of 67.2mm is slightly higher than average monthly rainfall (60.2mm). However, is not outside the normal range of November rainfall events for the area. The cumulative residual monthly rainfall data from July 2024 to November 2024 in the lead up to the landslide shows a falling trend. Cumulative residual rainfall is a consecutive monthly accumulation of the deviation from average monthly rainfall. Therefore, a rising trend indicates a wetter period and a falling trend indicates a drying trend.

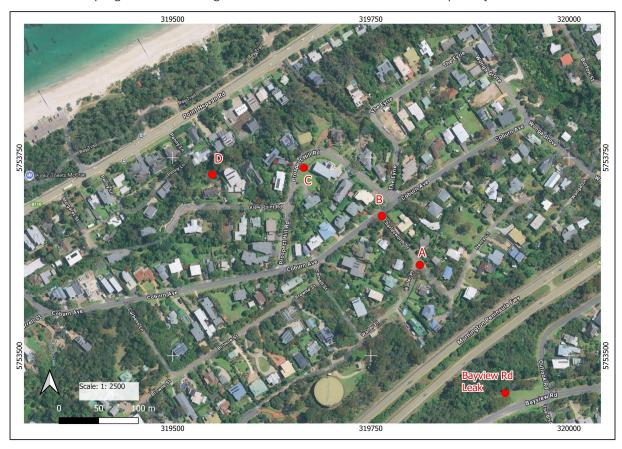
Figure 10 Location of sample sites referred to in Figure 11 and Figure 12 $\,$

- Bayview Road Leak
- A Waller Place and Charlesworth Street intersection where upwelling occurred
- B Coburn Avenue and Charlesworth Street intersection where upwelling occurred
- C 7 Prospect Hill where samples collected from building foundation drainage system
- D Location of landslide where a water quality sample was taken on 6 January 2025

All of these sampling locations are for groundwater associated with the shallow aquifer system.

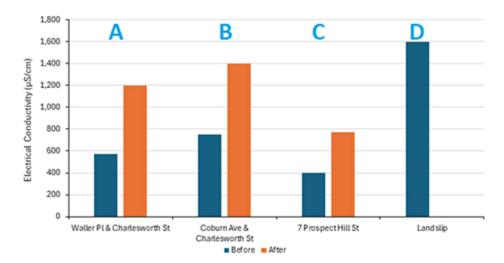
Figure 11: Summary of EC for selected sample locations showing Before and After Fix of Burst Pipe area

Figure 11 shows EC changes for the selected sample location shown in Figure 10 for EC values prior to / shortly after repairing the SEW burst compared to EC values post repair, which show a substantial increase in EC levels

as groundwater quality in the shallow perched aquifer returns to background water quality. In fact, it can be seen that in each case, the post-repair EC is almost exactly double the pre-repair value.

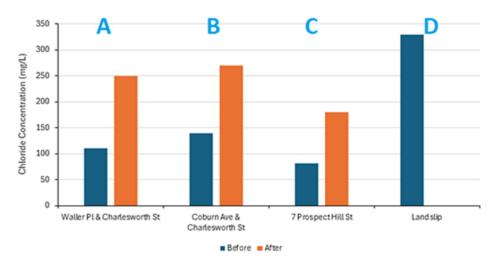
Figure 12: Summary of Chloride Concentration for selected sample locations showing Before and After Fix of Burst Pipe

A similar proportionate change in concentrations is also observed for chloride, as shown in Figure 12.

Overall, the increase in EC, and chloride, post repair of the burst pipe shows similar ratios.

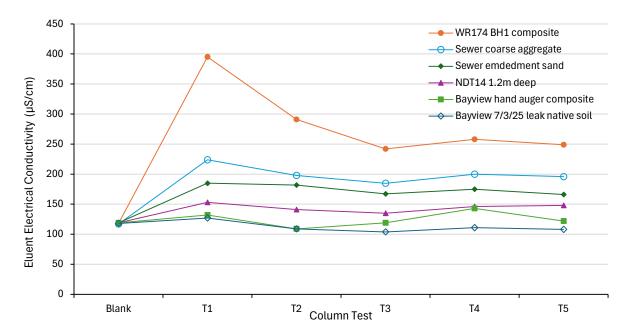
Figure 13: Electrical Conductivity Column Test Eluent Concentrations

- Samples for the Sewer coarse aggregate and Sewer embedment sand showed an increase in EC concentrations in the initial eluent compared to the blank concentration. However, the concentrations in the subsequent samples remained relatively constant. While the increase in EC is noticeably less than WR174 BH01 Composite, the sewer bed aggregate material shows some increase in EC.

- The eluent from the native soil samples (i.e., Bayview) showed no significant changes in EC concentrations relative to their respective blanks.

The column test data is consistent with the groundwater results assessed for the project. That is, the lower geological unit, represented by the sample ID WR174 BH1 composite showed the most significant changes in EC which is consistent with the EC measured at this location as part of the groundwater sampling event (e.g., EC maximum of $5,200~\mu$ S/cm).

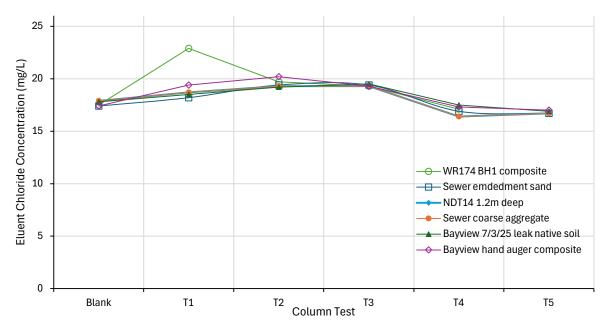
Figure 14: Chloride Eluent Column Test Eluent Concentrations

Chloride can also be considered as a tracer chemical (because it is very soluble and does not readily adsorb to mineral surfaces or exchange onto charged clay particles), and the data obtained from the column tests does support this conclusion. That is, while chloride is also present in the background water samples the column tests did not show a significant difference in changes of chloride concentrations for all the different matrices assessed. As such, should there be any change in chloride concentrations along a pathway, it is expected that it would be reflected across different profiles in a similar ratio. This is shown in Figure 14, as there is a close profile correlation in chloride concentrations across all different samples assessed. It is noted that the T1 sample for WR174 BH1 composite showed an increase in concentration; however, overall it followed a similar trend compared to all other samples.

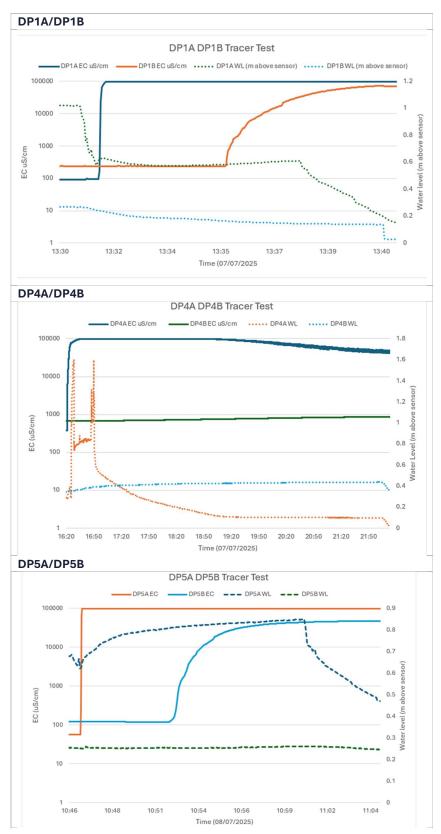
Figure 15: Tracer Test Plots

Tracer test results are present in Table 12 and graphically in Figure 15. Both DP1A/DP1B and DP5A/DP5B show clear responses indicating the ability of the embedment material to transmit water. It should be noted that the head differences that occurred during the test are higher than what would be experienced in reality therefore the travel times should treated with this in mind.

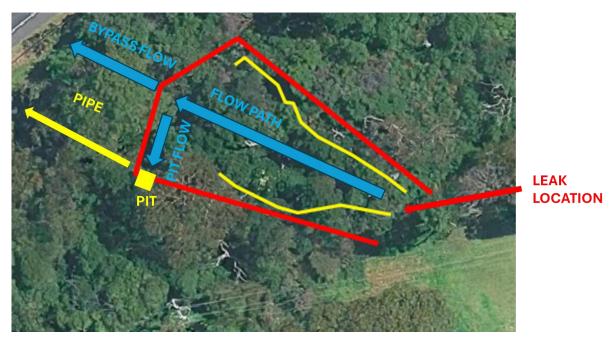
Figure 1: Estimated Sand Deposition Extent

The extent of the surface flows is estimated to be delineated by the extent of sandy materials deposited across the surface downstream of the leak location. The key features are shown on Figure 1.

The extent of sand deposition is delineated by the red lines in the above image. An example of the sand deposition area as viewed on the ground is presented in Figure 2.

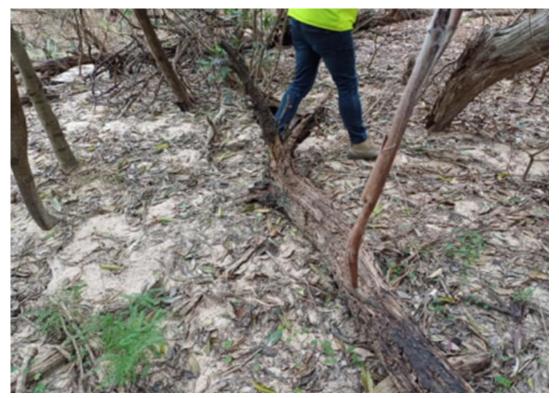
Figure 2: Example of Sand Deposition

The image presented above shows that the sand depositions area has a characteristic colour, overlies leaf litter is largely free of vegetation. The appearance is different to that of adjoining regions which are characterised by a greater vegetative coverage, darker colour and a greater depth of leaf litter across the surface.

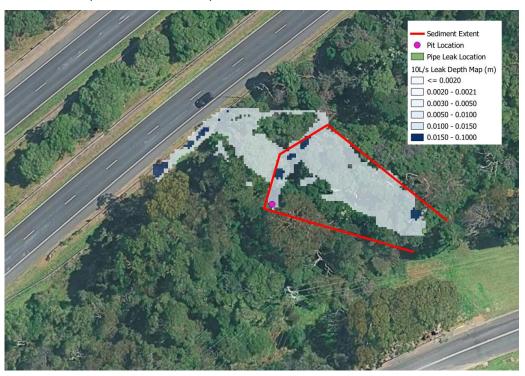
Figure 4: 10 l/s inundation extents

The inundation extents for 10 L/s and 20 L/s are shown in Figure 4 and Figure 5 respectively. All depths greater than 2 mm are presented on the outputs.

The outcomes indicate that the flood extent is similar to the observed extent of sediment deposition (red line). The outcomes indicate that the majority of the estimated outflow of 16 L/s would have travelled across the surface.

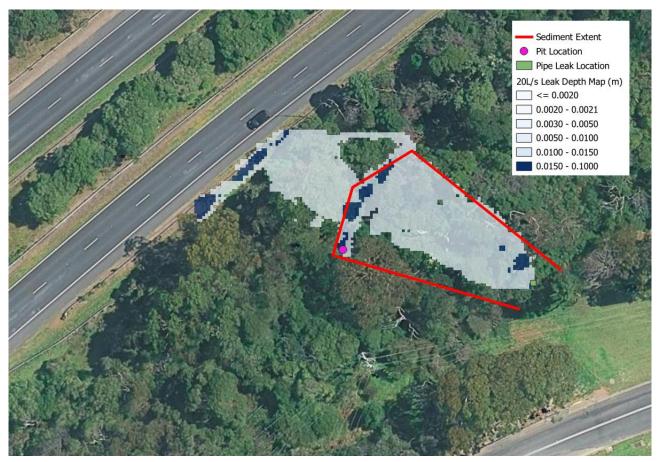
Figure 5: 20l/s inundation extents

The surface area of the inundation extent is estimated to be around 400 m². Applying an infiltration rate of 50 mm/hr suggests that an infiltration into the subsoil of up to 5 L/s could have occurred.

It is judged that the majority, or all, of the estimated peak leakage flow would be required to produce a sediment deposition pattern consistent with that observed at the site. The infiltration estimate indicates that around 25% of the 20 L/s flow could have entered the subsoils.

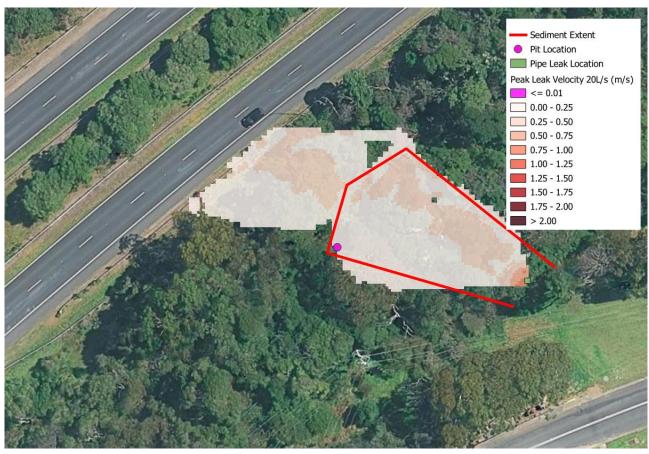
Figure 6: 20 l/s maximum velocities

A plot of velocities for the 20 L/s flow is presented in Figure 6.

Note that the velocities in the above figure cover a broader extent than that shown in the flood maps because velocities are shown for all depths, while the flood maps do not show depths less than 2 mm. The maximum velocities are around 0.5 m/s. This is consistent with a maximum diameter of around 1 mm for transported sediments.

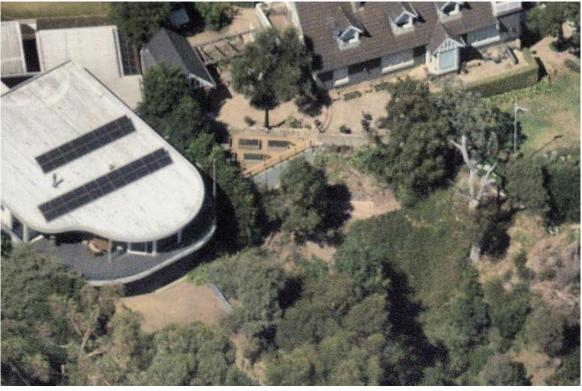
Figure 1 to Figure 5 show the site prior and after the 2025 landslide events. It can be seen that the retaining wall was not affected in the 5 January landslide (Figure 2), and the backscarp of this failure was approximately 3 m to 5 m below the toe of the retaining wall.

Figure 1: Aerial photo on 15 February 2024 (Nearmap 2024)

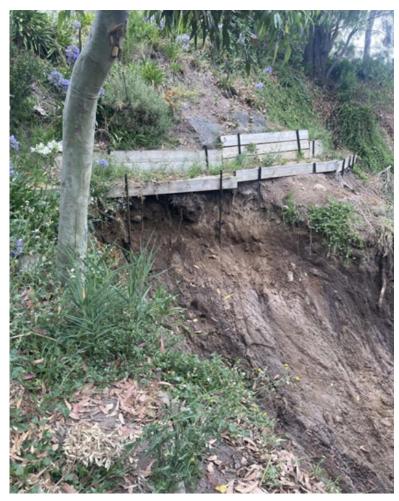
$Figure\ 4:\ Photo\ taken\ by\ SEW\ personnel\ on\ 6\ January\ 2025\ showing\ detail\ of\ backscarp\ of\ landslide$

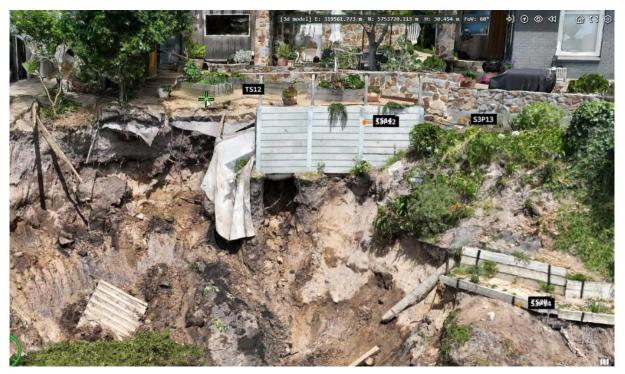
Figure 5: Drone footage of the retaining wall on 16 January 2025 $\,$

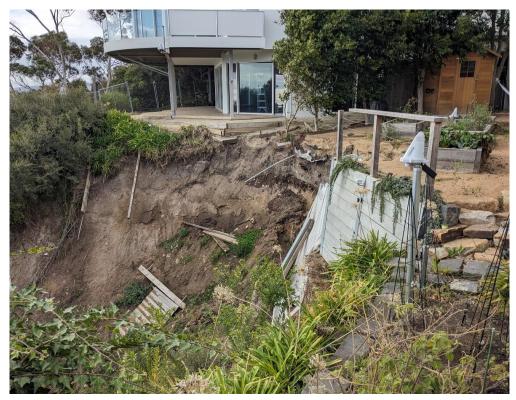
Based on BH01 and BH02 by PSM, the ground at 10 View Point Road comprised granular fill material overlying inferred granular colluvium material, underlain by residual granite recovered as Clayey SAND or Sandy CLAY and grading into XW granite as depth increases. Figure 7 and Figure 8 shows the post-failure condition of the slope. It can be seen that as surficial material (inferred colluvium soil) slipped down along the slope, weathered rock was daylighted under the retaining wall. Based on Figure 8 and site observations, the thickness of the inferred colluvium soil above weathered rock was approximately 1-2m.

Groundwater was logged at BH01 and BH03 at 4.5m below ground level (bgl) and 2.5m bgl respectively, and BH05 at 1.6m bgl. However, from site photographs and site observations, only minor seepage on the slope was identified based on damped debris and recent grown vegetation.

Figure 7: Site photograph looking at backscarp facing 6 View Point Road

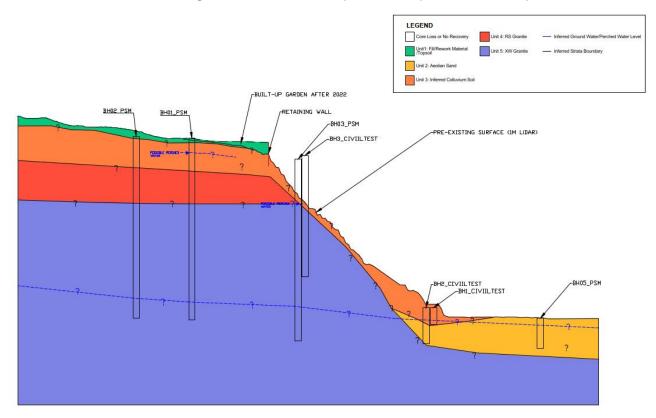
Figure 9: Ground model of assessed section (not to scale)

Based on assessments above, a ground model was developed for the replication of the slope failure.

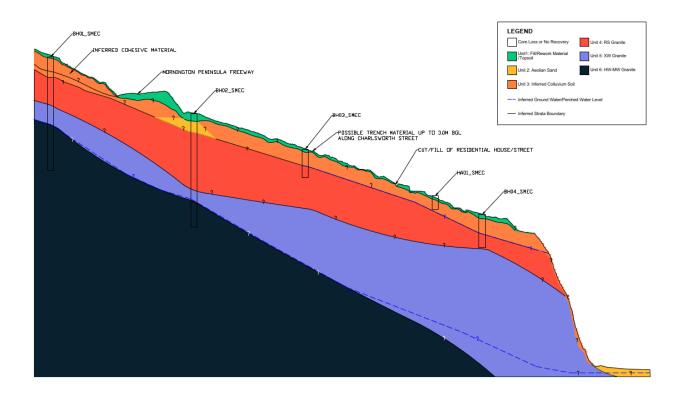
Figure 11: Ground model of site locality (not to scale)

The ground model below was developed to illustrate our understanding of the geological characteristics of the locality of the Site.

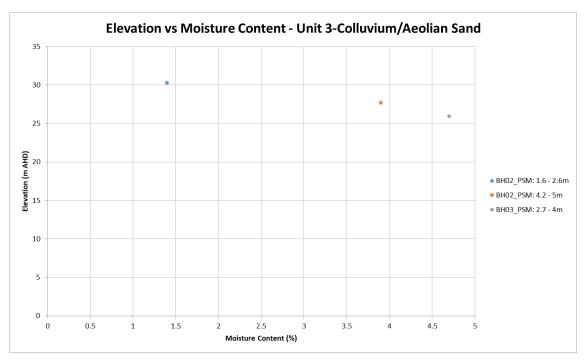
Figure 12: Unit 3 moisture content plot

Only two moisture content tests were performed on Unit 3 materials, showing in Figure 12. It can be seen that the results of the tested samples had less than 5% moisture content. Note that material in BH03_PSM at 2.7 m was logged as wet soil.

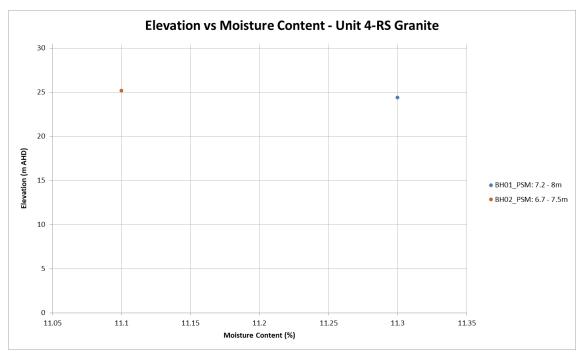
Figure 13: Unit 4 moisture content plot

Only two moisture content tests were performed on Unit 4 materials, showing in Figure 13. It can be seen that the tested Unit 4 materials had less than 11.5% moisture content.

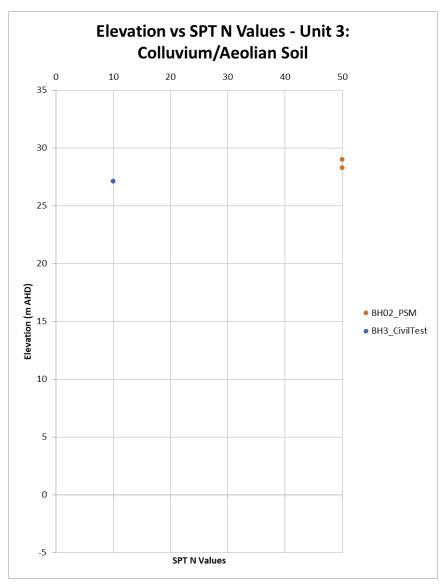
Figure 15: Unit 3 SPT plot

A total of 8 No. Standard Penetration Tests were conducted by PSM in 2025 and CivilTest in 2022. The results of SPT in Unit 3 and Unit 4 soil are presented in Figure 15 and Figure 16. Note that SPT N value of 50 represents refusal. The key findings of the SPT tests were as follows:

- All SPT in Unit 3 soil were conducted within granular material. SPT in BH02_PSM refused which was
 potentially due to the presence of gravel;
- Only one SPT in Unit 4 soil was conducted within cohesive material which had SPT N value of 12 indicating consistency of stiff. All other SPTs had N value of 25 to 33, indicating relative density of medium dense to dense;
- Due to the limited amount of data, it is difficult to derive soil parameters from SPT results.

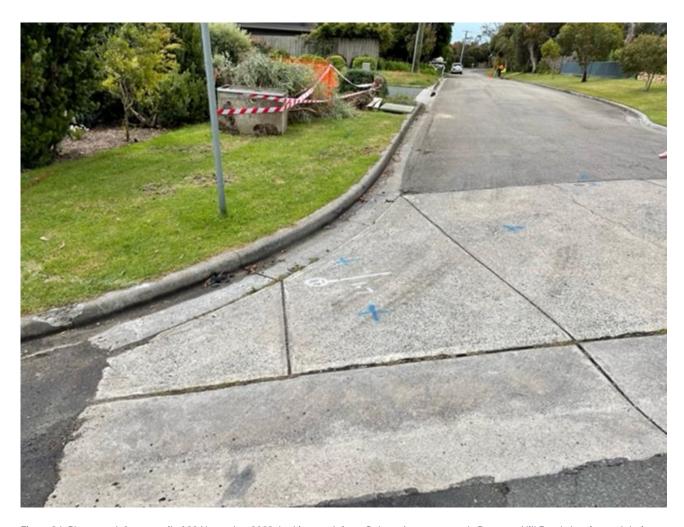
Figure 24: Photograph from email of 22 November 2022, looking north from Coburn Avenue towards Prospect Hill Road showing undulating concrete pavement construction.
